# NRHS Facilities

NRHS Space Committee

1-22-2015

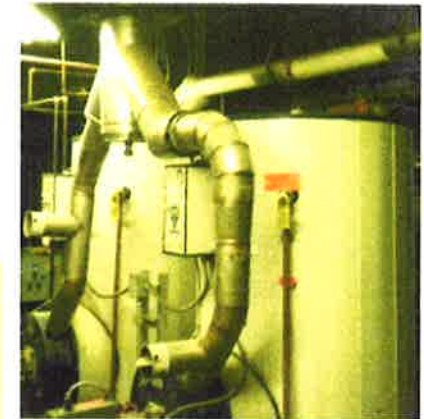
Domestic Hot Water Heaters

- We do have issues with domestic hot water circulation and frozen pipes.
  - The building automation system is two generations old and eventually needs to be updated which will involve replacing the main controller and all sub-controllers in the building.

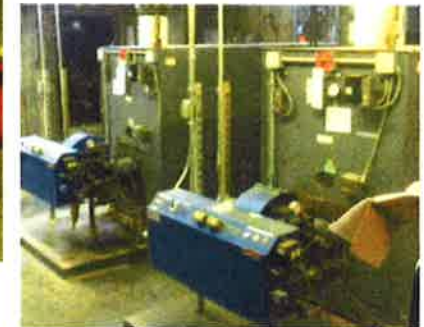
Boilers

- Mechanical Systems: Mechanical system design does not seem to have expansion capacity. Additional square-footage would require a dedicated HVAC system or retrofit of existing. Current boilers are approximately 20%–30% redundant.
