Nashoba Regional High School

Building Overview

FACILITY DESCRIPTION

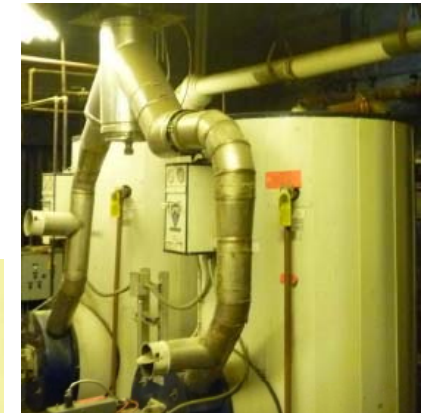
(2) Turbopower Domestic Hot Water (DHW) with 399 MBH input capacity provide useful hot water to the facility.

Domestic Hot Water Heaters

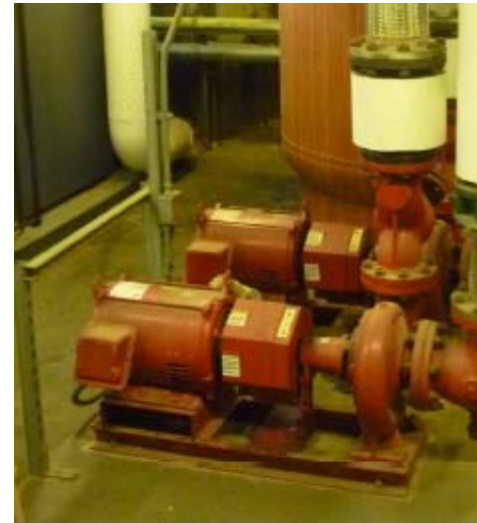
(2) HW pumps provide 400 GPM of water with 75 ft head, 68% efficient, to the building's main heating loop. Each is powered by a 15 hp, 92% efficient motor.

Hot Water Pumps

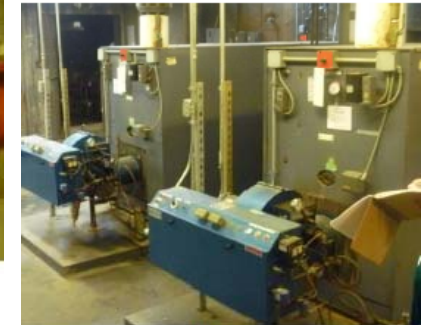
(2) Weil-McLain Model 1588 hot water (HW) Oil-fired boilers with 4,763 MBH input and 80.2% efficiency provide HW to the facility's heating loop. Each is equipped with a 3 hp burner motor.

Boilers

- Two boilers were replaced with Weil McLean section boilers and Powerflame burners in 2002
- Most roof top and air handling units were replaced in 2002. The system is a mix of radiant hot water and hydro air with DX cooling

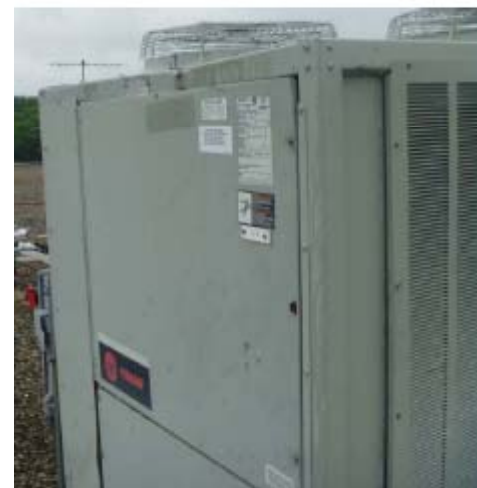
(13) Air-Cooled Condensing Units (ACCUs), mounted on the roof, serve AHUs in the facility. The units' cooling capacities range between 36 and 595 MBH.

Condensing Unit on Roof
